# **Navajo Abandoned Uranium Mine**

## **Site Screen Report**

### **Plot 9 AUM Site**

#### **Navajo AUM Northern Region**

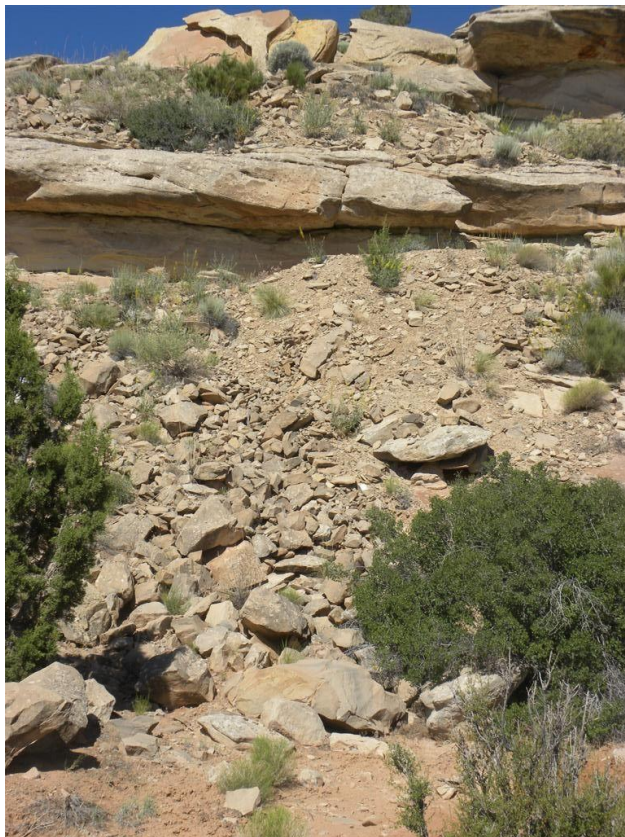
Unfinished adit 5' x 4'; reclaimed adit buried in stone

Photo 3. Plot 9 site, buried adit

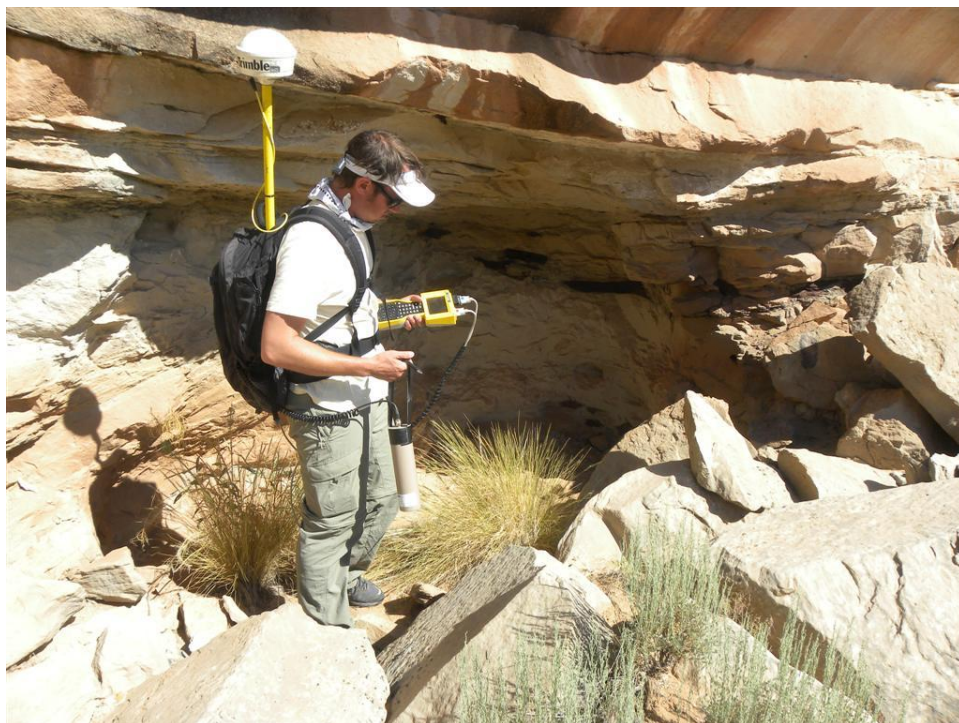
Photo 4. Plot 9 site, unfinished adit
